Tropical Storms as Triggers for Intensified Flooding and Erosion Processes in Southernmost Mexico

Thomas Dekarski¹, Markus Praeg¹,
Dirk Wundram² and Michael Richter¹

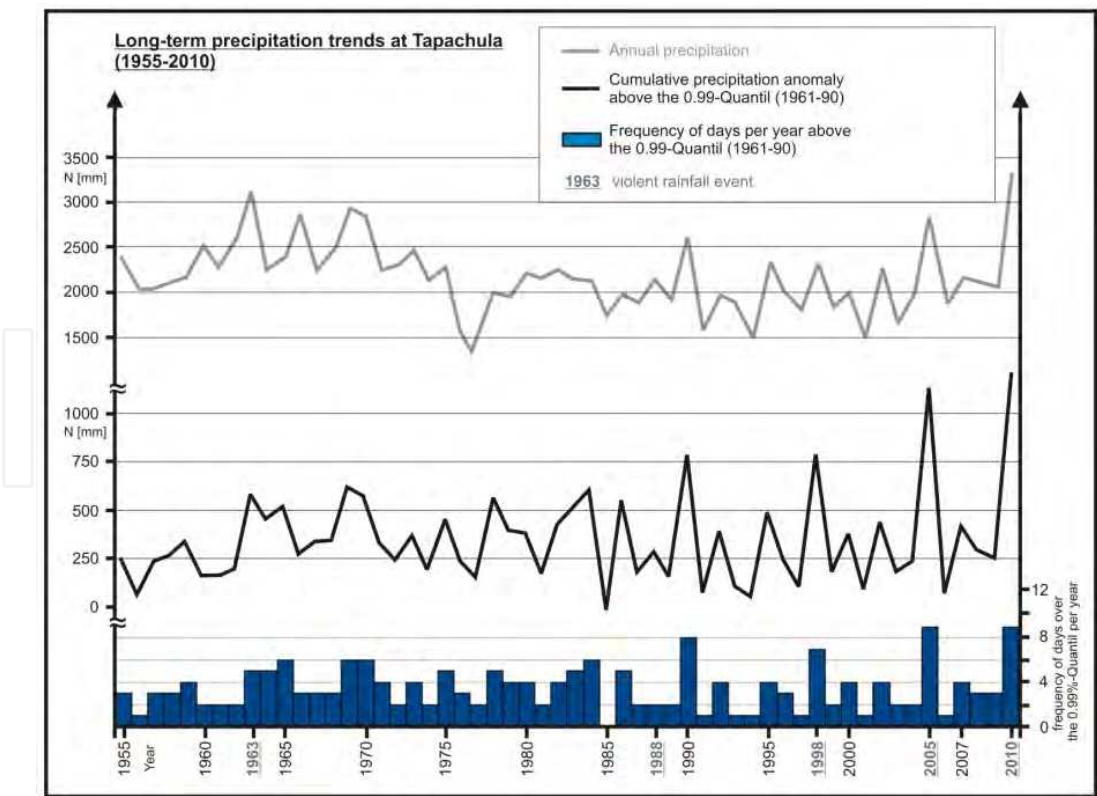
Fig. 6. Rainfall characteristics (annual amounts, anomalies, frequencies) during the last 57 years at Tapachula (179 m a.s.l.)

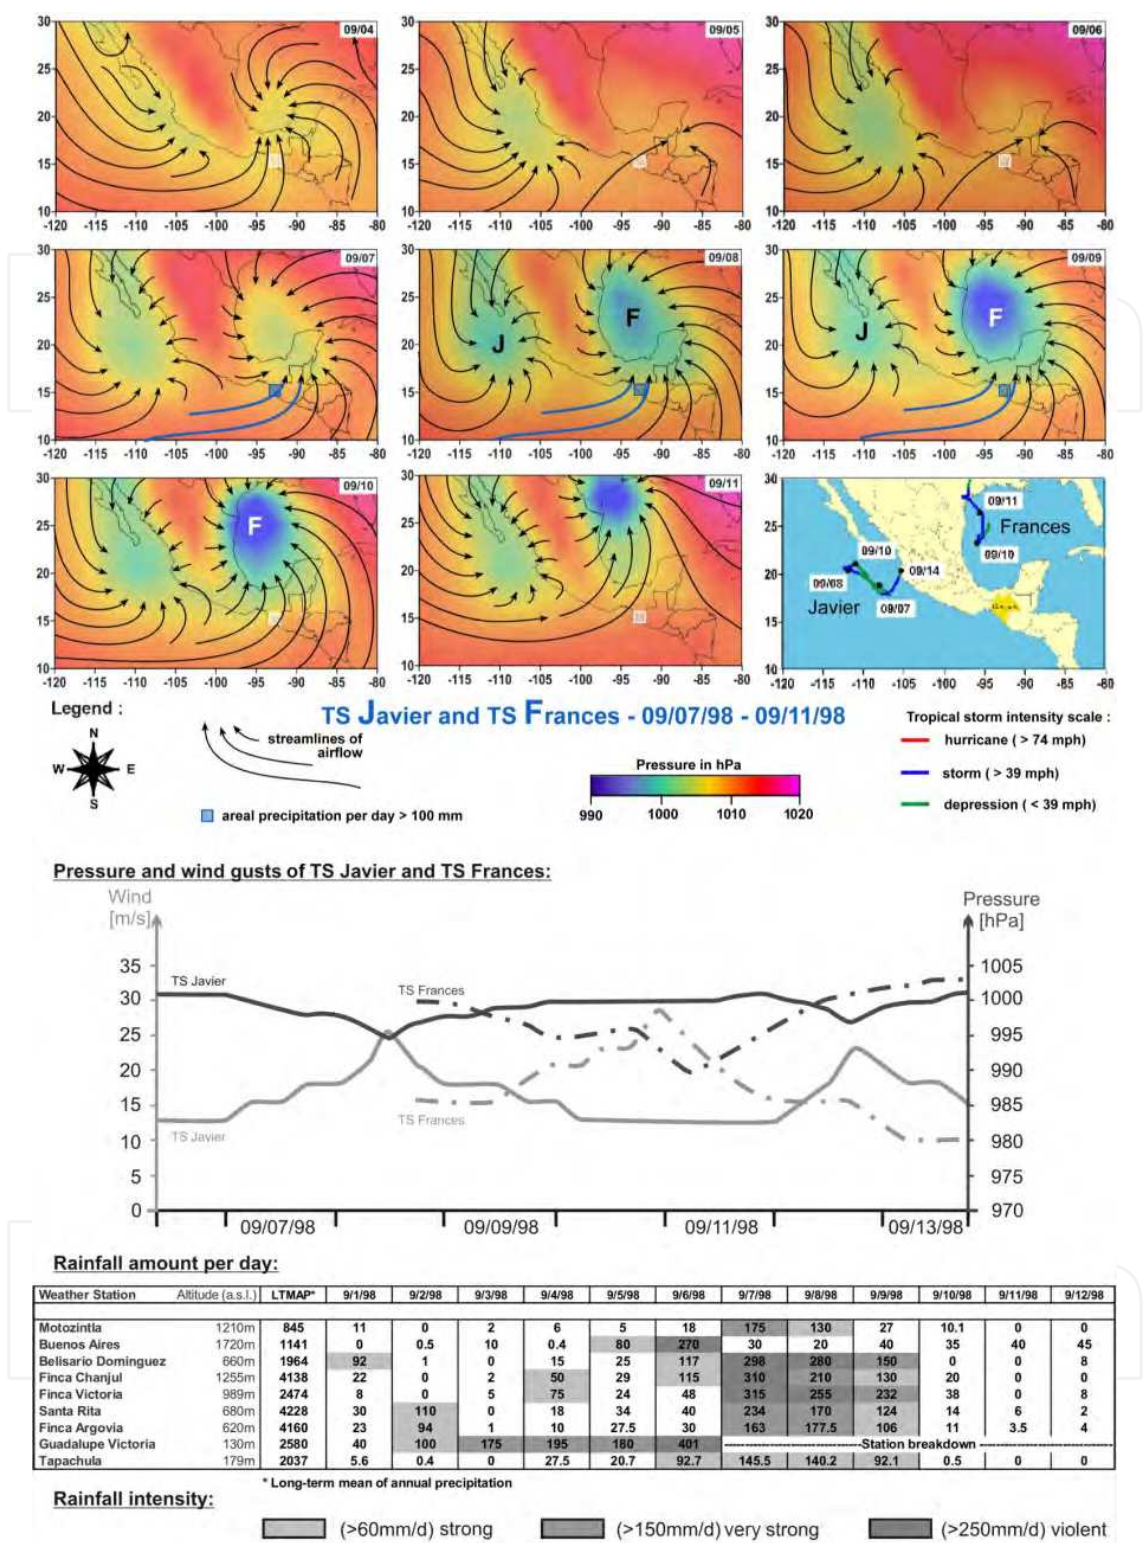
Fig. 7. Coloured maps: Pressure development and air flows during tropical storm activity of Javier and Frances from Sept. 4th to 11th 1998; blue stream lines indicate the direction of main humidity transfer during wet days (derived from NCEP/NCAR Reanalysis data). Black and white diagrams: Wind speeds and pressure (NOAA) as well as rainfall amounts from several stations during the 12-day period (CONAGUA, and private stations). Note the double effect by the traverse of two storms

The orographic lift of the moist saturated air finally led to deep convective showers in the mountainous region and above in its dry valleys. The transfer of the moist saturated air is represented by blue stream lines in the map sequence of fig. 7 and 8. Furthermore, the same maps indicate that the atmospheric flows during these events were characterized by winds eventually diverted by topographic barriers and then pulled through the Isthmus of Tehuantepec towards the Gulf depression.

Tropical storm Frances was formed out of a broad area of low pressure and widespread showers in the southern Gulf of Mexico and the western Caribbean. The existence of three poorly-defined tropical waves in the area may have contributed to the formation of a tropical depression on 8th September. In addition, the close interaction between larger systems of rainstorms (Javier) developed over the Pacific. The rain fell in torrents for at least three days until the tropical system moved slowly northward and the humidity transfer into the mountainous region of the Sierra ended. At the windward station of Guadalupe Victoria concentrated deep convective showers account for the stations breakdown (fig. 7, table). The influence of tropical storm Javier on the prolonged rainfall in the Sierra was only marginal. But it contributed to a broader area of disturbed weather that persisted over the tropical eastern Pacific. Note that the dark blue colour of Frances hints to lower pressures than in case of Stan. Nevertheless, the potential of 2005 was never reached because the constellation was different (extension of the whole complex as well as vigorousness of the storm centre; compare diagrams in fig. 7 and 8).

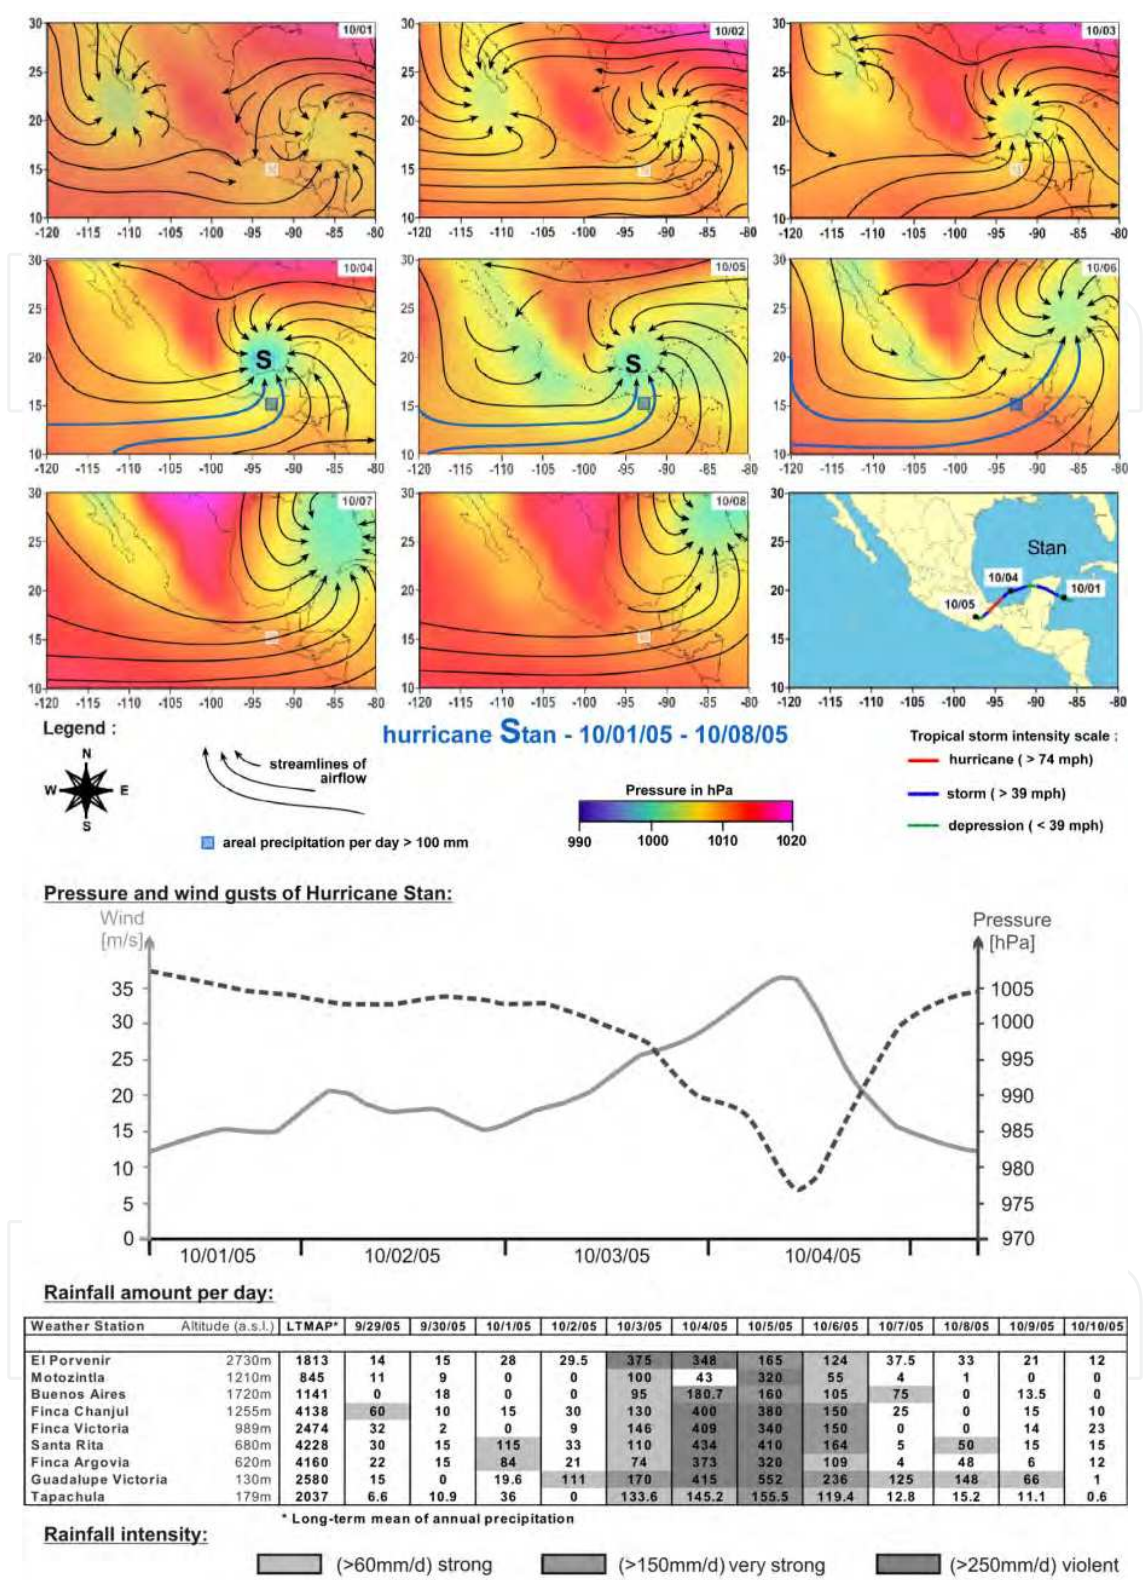
Fig. 8. Coloured maps: Pressure development and air flows during passage of hurricane Stan from Oct. 1st to 8th 2005; blue stream lines indicate the direction of main humidity transfer during wet days (derived from NCEP/NCAR Reanalysis data). Black and white diagrams: Wind speeds and pressure (NOAA) as well as rainfall amounts from several stations during the 12-day period (CONAGUA, and private stations)

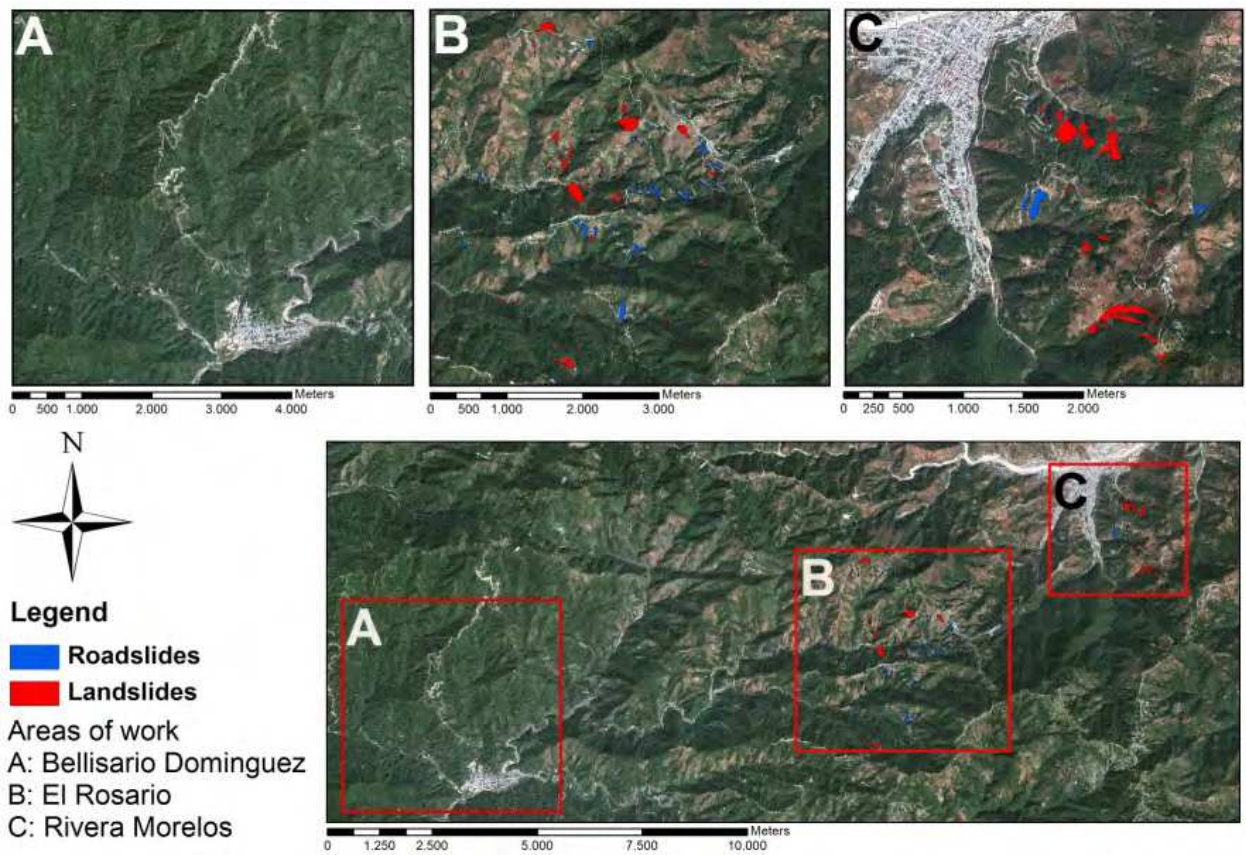
Fig. 9. Overview and detail of the research areas with road- and landslides derived from satellite images presented by GoogleMaps (recording date 12/19/2010)

Additionally, landslide and erosion processes cause extensive land losses and threaten cultivated land and infrastructure on the pacific slope of the Sierra Madre as shown in fig. 9. The study area along the upper Valley of the Huixtla River includes parts of the pacific slope from the town of Belisario Dominguez towards the north-east over the natural watershed at Las Cruces into the rain shadow flank around Motozintla. From this region three separate zones are presented here. The first is located along a crest north of Belisario Dominguez. The second zone is situated in front of the watershed nearby the federal road between Huixtla and Motozintla. The third area is a mountain escarpment south of Motozintla around the hamlet of Rivera Morelos. All examples represent different important features of common mass movement processes in the Sierra and offer different climate, land-use and geology aspects. The parent municipality of all three areas is Motozintla.

Same as off-road landslides, the hot spots of road slides concentrate on drier sections of the Sierra Madre. In some cases they even exceed the number of out-of-the-way slides as interpretable by the red-blue patchwork in Fig. 9 (extract b). The slope failures depicted in Fig. 16 exist since several years, are quasi-permanently active, and some of them can be divided in a lower dump section and an upper excavation part. In the first case the forest sites below the road are dissected by lamellar debris (e.g., between the creek and the unpaved road in the middle of fig. 16, right). In case that a slide is located just in the uppermost part of a catchment of a stream like in the upper right half of fig. 16 (left), dump deposits are removed during rainy phases and hence, accumulation succeeds alongside the

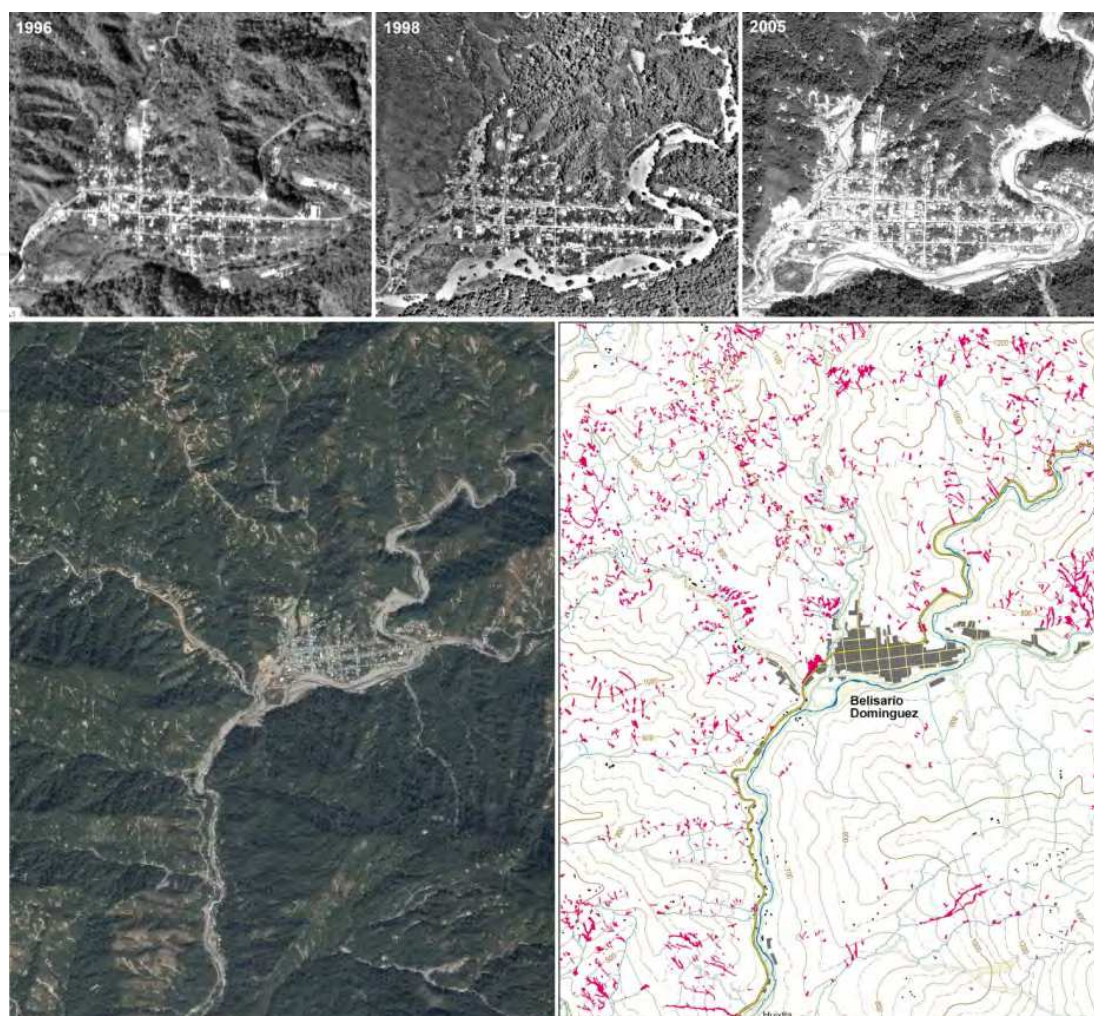
Fig. 10. Top: Aerial pictures of Belisario Dominguez in 1996, 1998, 2005 from INEGI. Below: The surroundings of the same town affected by small and shallow landslides after hurricane Stan 2005 (Quickbird image from DigitalGlobe, recording date 15/12/2005)

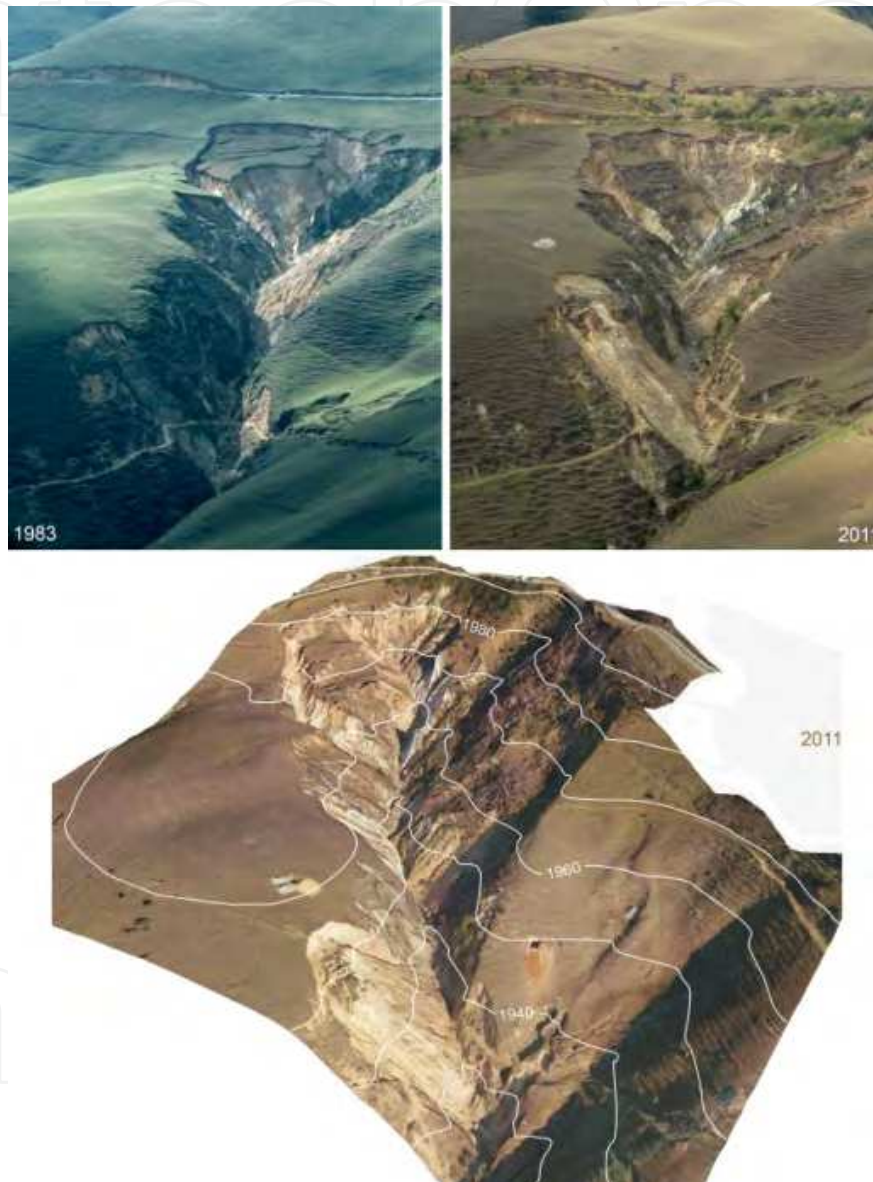
Fig. 11. Development of a landslide near the watershed at Las Cruces. 3D-image derived from aerial images taken by an octocopter; contour lines derived from GPS-measurements on site

Many of the larger slides were not triggered by the events in 1998 and 2005 but can be decades older and are modified in a subtle way. A convincing example is the compound landslide in fig. 11 located only few meters in front of the watershed at Buenos Aires within a vast pasture

area. The complex slides within an arroyo (dry creek) of slow retrograde erosion exist for more than three decades and some of its sections are slowly altering their aspect. A comparison of the two photos of 1983 and 2011 indicates, for example, that the rotated blocks below the uppermost scarp are meanwhile more dissected, slightly slipped off and covering only half of their former size. Additionally, few side scarps within the arroyo hardly expanded during the three decades. However, on the other hand the two pictures point to a surprisingly stable situation which contrasts completely to a nearby form, that is developing further.

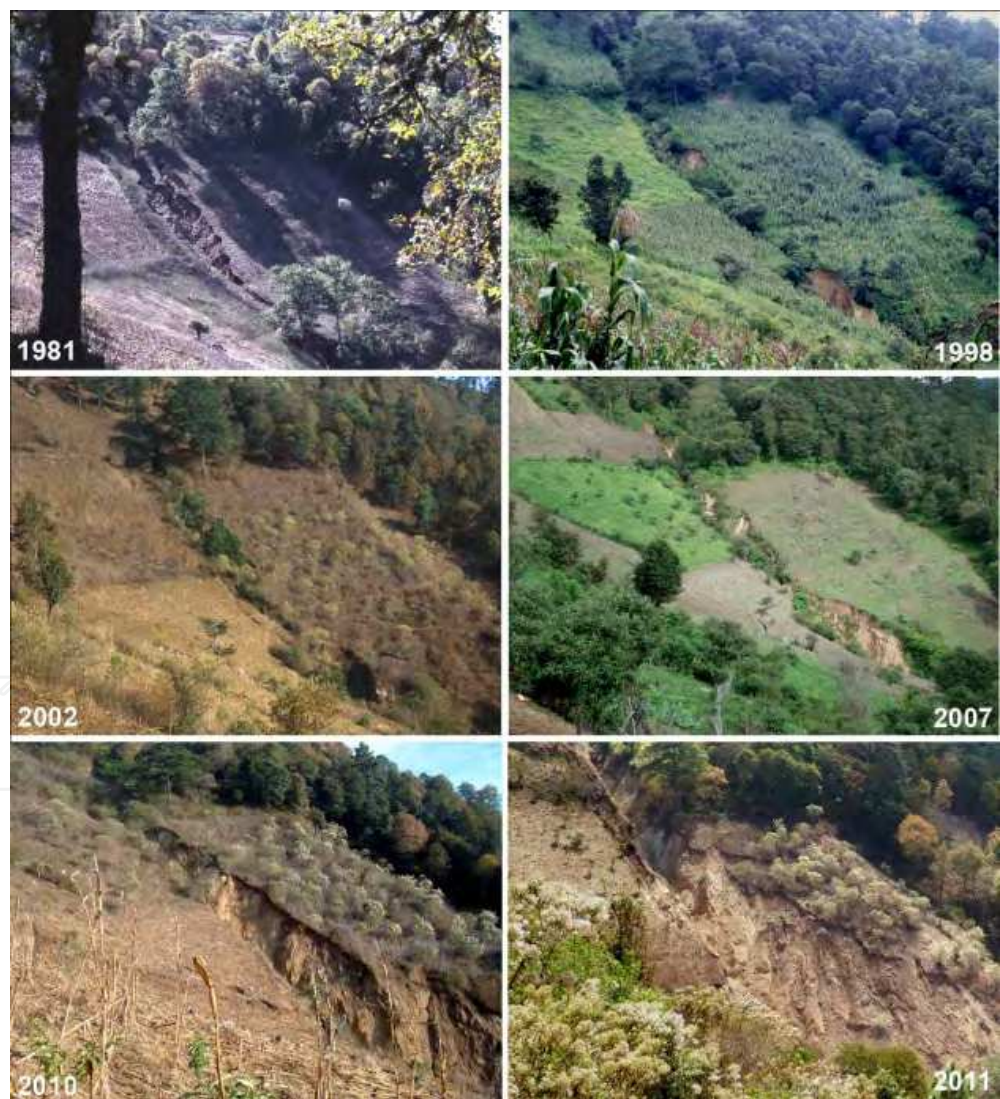
Fig. 12. From gully towards valley – ongoing erosion effects near Morelos above Motozintla through 30 years (photographs by M. Richter)

This is the study area of Rivera Morelos beyond the watershed, where small devastations are nearly absent and large denudation forms of more than 10,000m² are characteristic. The height above sea level of 1300 to 1900 m a.s.l. is almost the same as in El Rosario, but the annual precipitation is less. Here, gully erosion is the dominant mass movement process. Situated in the north east of the study area (fig. 9 C) the old gully form in fig. 12 (upper left)

is developing towards an enormous valley in the lower right of the sequence of the same site. The specific characteristic of this area is an ongoing and vivid development of mass movement forms. Only three vaster erosion scars, e.g. the gully in fig. 12, existed before hurricane Stan. Until today their number rapidly increased, their outlines expanded and the baselines deepened. In contrast to the other study areas fresh mass movements occurred during the rainy season in 2010 when heavy rainfalls intruded by the tropical depression 11-E. Most of the processes were once again gullying, in some cases accompanied by rotational sliding and toppling through undercutting. The anthropogenic influences combined with a micro-climatically enforced physical weathering of meta-granodiorites as parent rock, which leads to coarse-grained substrate, are reasons for a growing instability in this region and can explain the meanwhile huge gullies as a dominant mass movement form. It is no surprise that the deforested pine forest area is the main new hazard source. The growing problem here is the development from gullies towards valleys, which means a lot of land will be lost and a stabilisation by reforestation measures on the slopes of the completely bare and deeply dissected new V-shaped arroyos becomes an illusion.

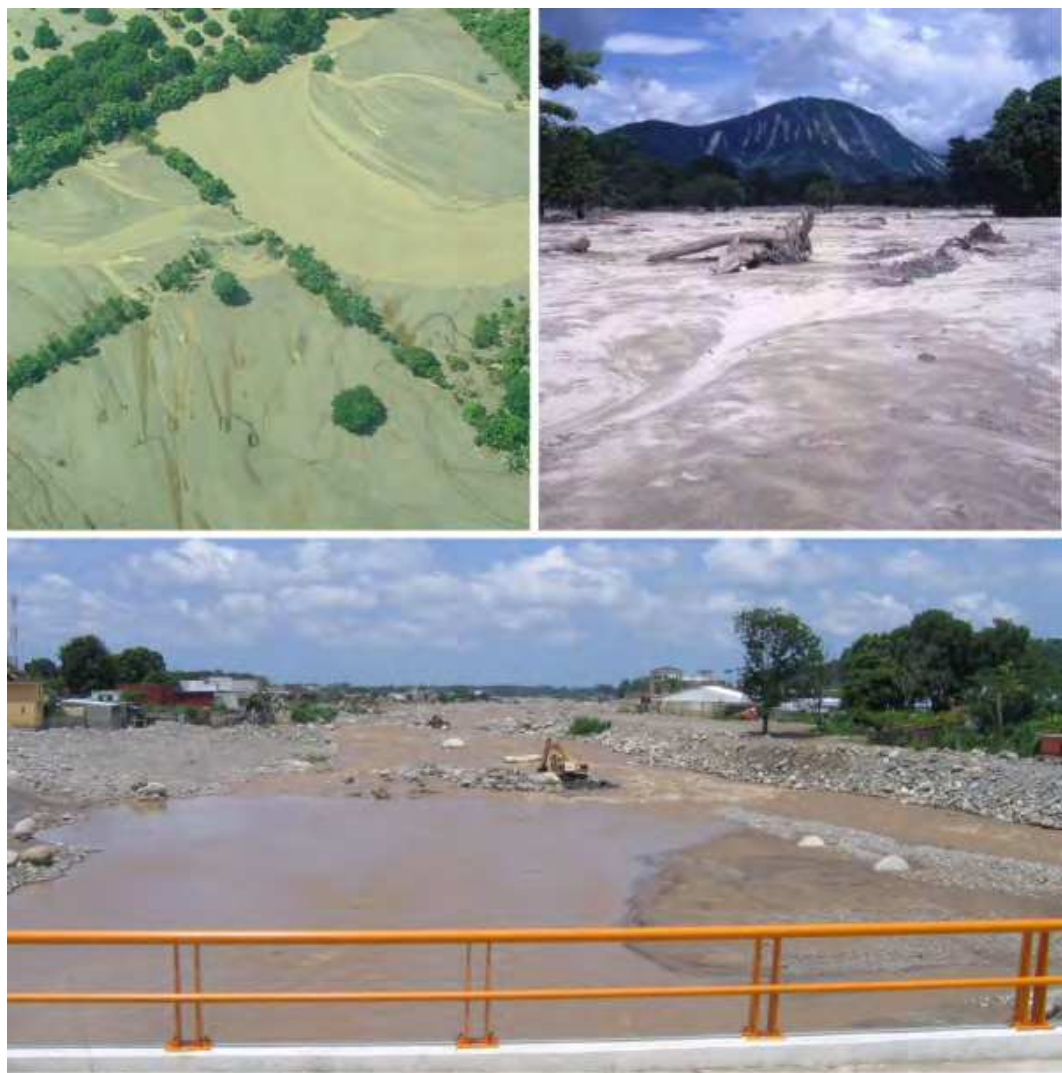
Fig. 13. Inundation and sedimentation in the surroundings of Rio Coatán near Tapachula caused by hurricane Stan (2005, left) and of Rio Novillero near Mapastepeque after tropical storm Frances (1998, right). View from the Rio Huixtla bridge after the Stan floods (below)

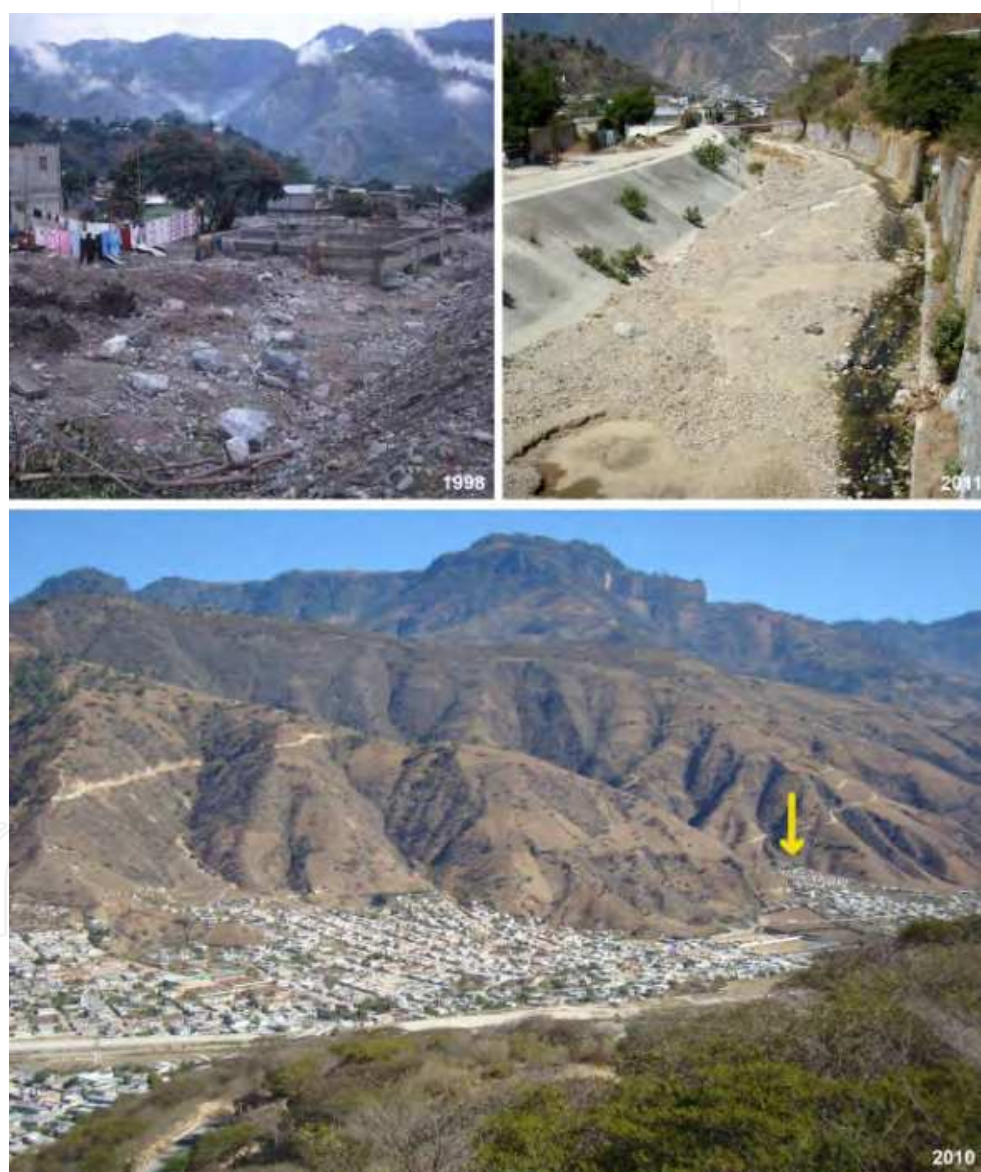
Fig. 14. A mostly dry channel of a tributary creek passing through Motozintla (upper left after the disaster in Sept. 1998, upper right in Feb. 2011 after channelling) and overview on those suburbs of the town which were installed mainly after the 1998 event; the yellow arrow marks a recently established quarter highly endangered by flash floods

Nevertheless the death toll during the 2005 event was a little less (28 fatalities) although the rainfall amounts were higher yet and the floods larger than in 1998 (375 mm in two days and more than half of the average annual input during four days, i.e. 518 mm versus 845 mm). The slightly lower impact is partly due to the dammed tributary creek shown in fig. 14, which did not yet exist before 1998 and was still too small before 2005. Many of the casualties in 1998 were attributed to overflows and debris accumulations along the meanwhile channelled tributary (fig. 14, left and right upper part), where the solid reinforcement protects the lower parts of town from massive flooding. But as channel stabilization was performed with only the 1998 flood as the design event, a strong 2010 storm (tropical depression 11-E, Sept. 4 and 5, rainfall data not yet available at date of submission) banked up heavy debris loads alongside and beyond the concreted creek wall.

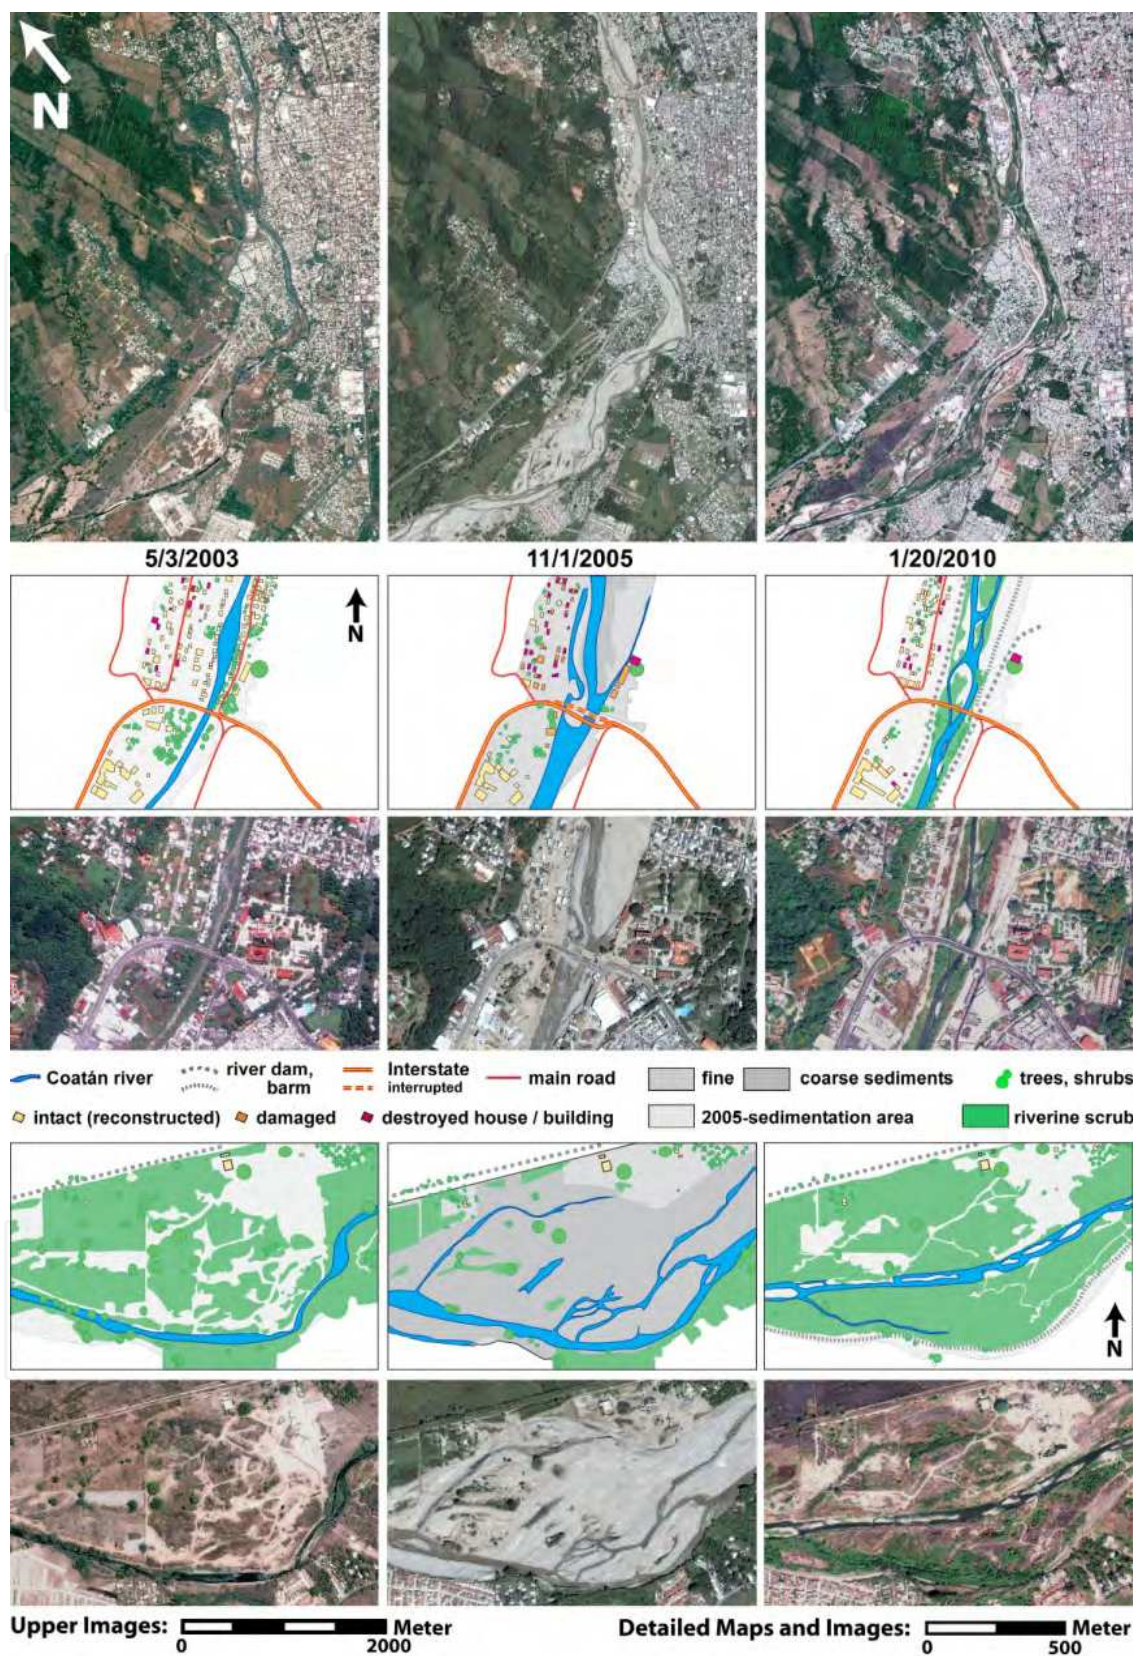
Fig. 15. Effects of the floods along the Rio Coatán at Tapachula in consequence of the hurricane Stan event in Oct. 2005 presented by satellite images before (left row), three months after (middle) and 40 months after the event (right)

The 2005 event was probably the worst disaster that ever hit the city. Four bridges and the railway were carried away cutting the town into two parts. The photo sequence in Fig. 15 proves that main parts of the city were isolated from major transport links to the north of the country. 10 barrios were heavily damaged and 12 were flooded with mud deposits. More than 2,000 homes were destroyed and nearly 100,000 people affected (Murcia & Macías 2009). The figure shows also the fast recuperation in the river bed, where many areas are inhabited by plants once again although the short distance between the high mountain range and the lowland favors the flood danger. In the upper parts of the Rio Coatán for example about 8653 ha are partly or totally deforested. This leads to an erosion rate up to 9t/ha higher than mountain slopes with endemic forests (Mundo Molina 2010). In the case of Tapachula the 4064 m a.s.l. high Tacaná Volcanic Complex in the backcountry enlarges the sediment load.

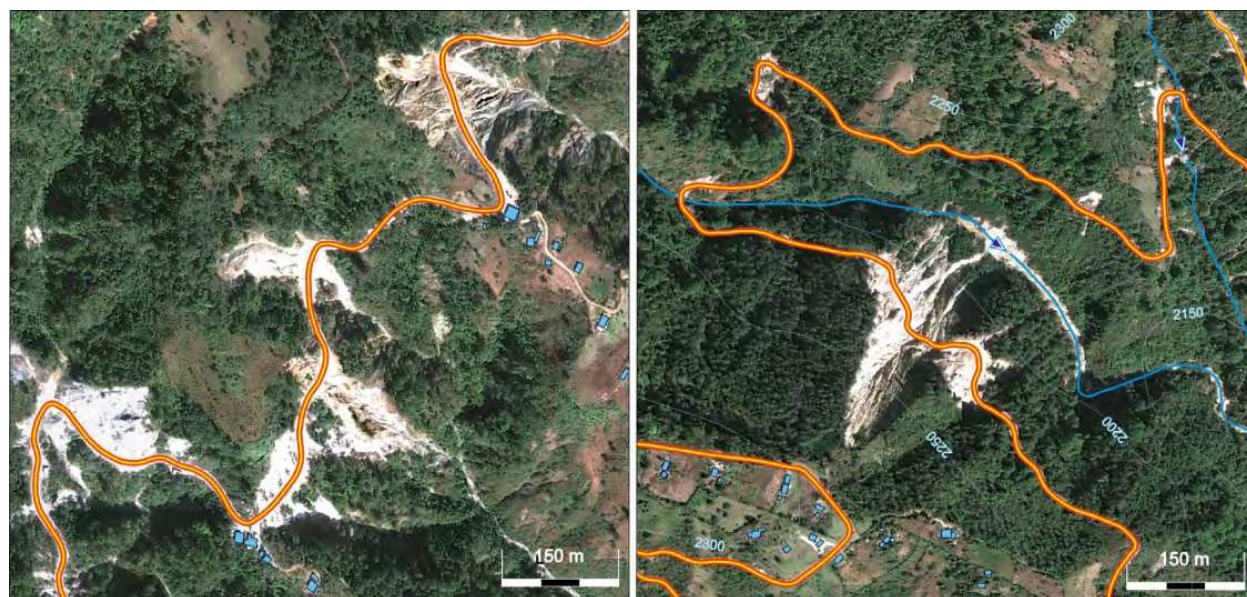
Fig. 16. Roadside slides above Buenos Aires (left; locality Las Flores Buenavista, road towards Porvenir) and below Niquivil (right; locality Tuxchamén, dirt road towards Pavencul). Blue quadrates = houses and sheds, blue line = creek with arrow of flow, red-yellow lines = roads (source Google maps, date taken November 2010)

ditch. The just mentioned example in the picture forms a rotational slide which is well recognisable by multiple slide blocks due to a disruption of the initial and principle scar. Here, fault scarps and fractures create a continuous slope instability causing frequent slip and toppling failures leading to extended roadblocks during the last two decades.

In contrast, the example on the right (fig. 16) stands for an enormous translation slide with a height of approximately 100 m and an extension of about 300 m, which gradually develops since the early 2000s and deepens stepwise by repeated gully erosion processes. Here, solely road construction is responsible for the sliding process, since before the intervention the environment was governed by a dense mountain forest. Same as in the Buenavista example, the Tuxchamén sliding resulted from an artificial excavation of the underlying stratum without the establishment of a firm fundament. In consequent, close-by home- and farmsteads become endangered like several premises below or also above the road slides, respectively, marked by blue rectangles in both aerial pictures in fig. 16. Spillage and fall risks of roads and houses in the Sierra are not only given by heavy rainfalls but also by relatively frequent earthquakes of a maximum magnitude between 3 and 5 or by a combination of waterlogged substratum and temblors.
